Prepared by Demeter Design for the Siuslaw Watershed

Map 7 - Alternate Measure of Bank Condition

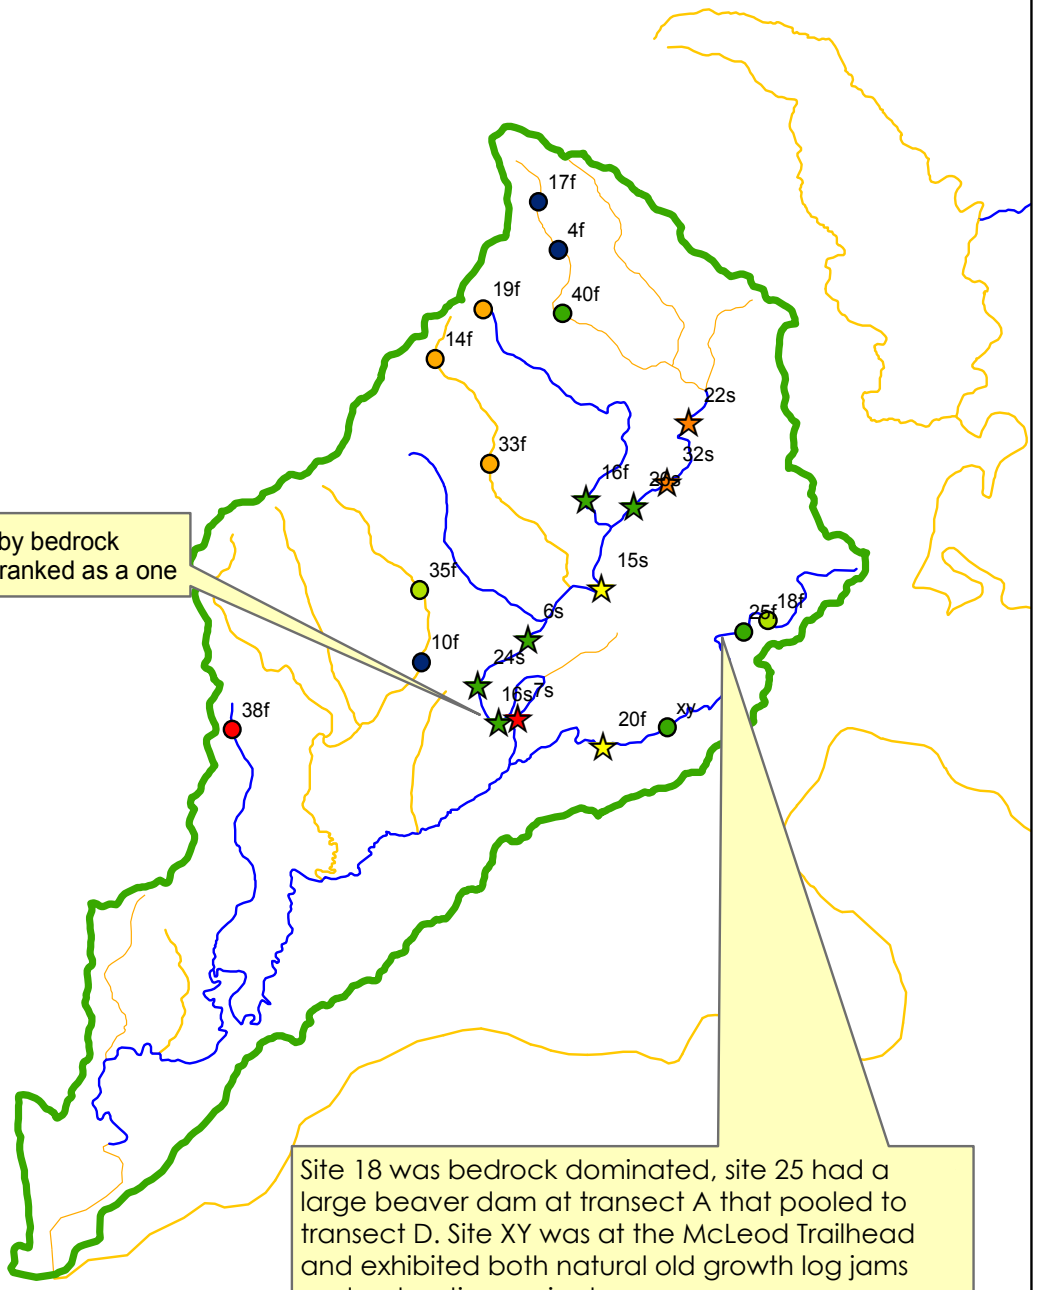
Sites 6, 16, 24 are dominated by bedrock outcropping which are always ranked as a one

Site 18 was bedrock dominated, site 25 had a large beaver dam at transect A that pooled to transect D. Site XY was at the McLeod Trailhead and exhibited both natural old growth log jams and restoration projects
